**DRAFT**  
**Supplemental Watershed Plan No. 7 & Environmental Assessment**  
**for the**  
**Rehabilitation of Floodwater Retarding Structure No. 77**  
**of the Upper North River Watershed**  
**Augusta County, Virginia**

**Proposed Action:** Rehabilitate Upper North River Watershed Dam No. 77, Hearthstone Lake, to meet current NRCS safety and performance standards for a high hazard dam.

**Purpose and Need for Action:** The Upper North River Dam No. 77, Hearthstone Lake, does not currently meet NRCS safety and performance standards for a high hazard dam or Virginia Division of Dam Safety standards for the capacity of the vegetated earthen auxiliary spillway. There are lives and property downstream of this structure that need flood protection. The purposes for federal action are to meet current safety and performance standards for a high hazard dam and maintain flood protection for downstream properties.

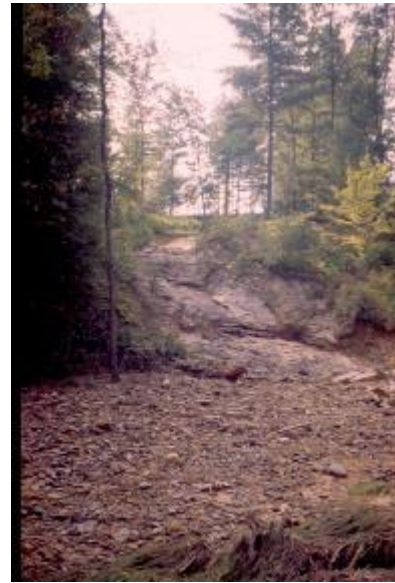
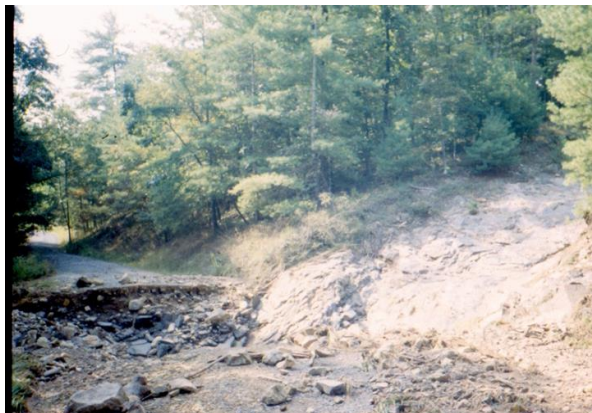
Figure 1. (Clockwise from top left) After Hurricane Fran in 1996 - the flood pool, the damaged hillslope downstream of the auxiliary spillway, and Tillman Road below the hillslope.

Hurricane Juan, in November of 1985, caused approximately 2 feet of flow in the auxiliary spillway but there was no damage to the auxiliary spillway. In September 1996, there was over 5 feet of flow in the auxiliary spillway from Hurricane Fran. There was no damage to the constructed outlet; however, the hillslope below the auxiliary spillway sustained some erosion at the upper end. The small gullies were filled with rock riprap and a diversion was installed at the end of the constructed auxiliary spillway to route water into the riprap areas.

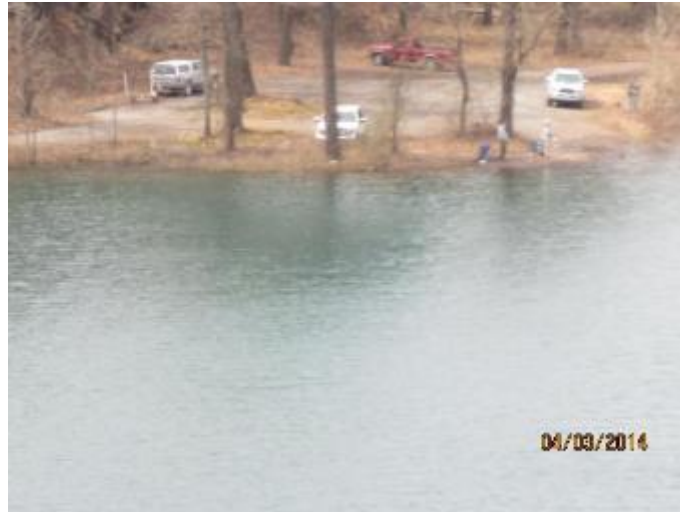
Figure 2. View of boat ramp at Hearthstone Lake.

**Recreation:** Hearthstone Lake provides recreation to fishermen and day visitors to the National Forest and the recreational facilities at the reservoir (Figure 2). It is highly valued by the local community. Other lake-based recreation activities associated with the reservoir include boating

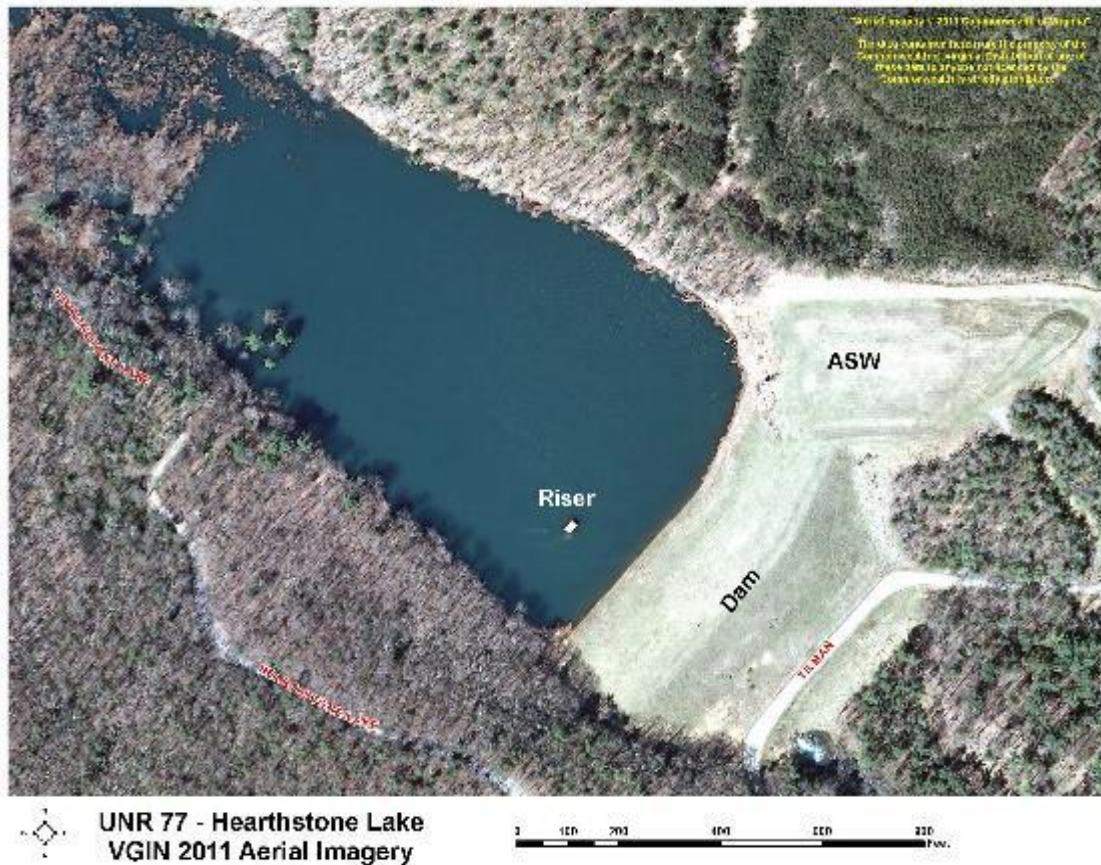
Figure 3. The Hearthstone Lake dam, auxiliary spillway, and pool.

Location and Layout: Upper North River 77 dam and reservoir are located in a narrow valley with steep ridges. It is adjacent to and upstream of an unpaved secondary road (Forest Service Road 101 – Tillman Road) (Figure 3). Earthfill was placed in the valley of Little River to create the embankment with the auxiliary spillway (ASW) excavated out of the left abutment. The existing ASW exits to a hillslope that drops about 75 feet to the valley floor on a 35 to 40% grade. The hillslope consists of sandstone, shale and siltstone. Tillman Road is located at the bottom of the hillslope and also traverses the downstream stability berm of the embankment. It presents

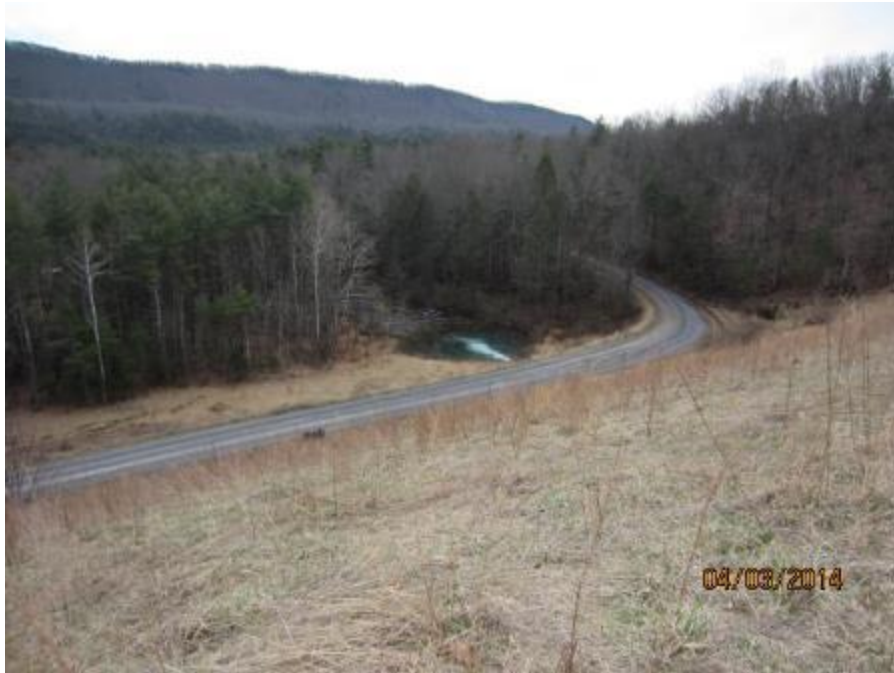
Figure 4. Back slope of dam and Tillman Road.

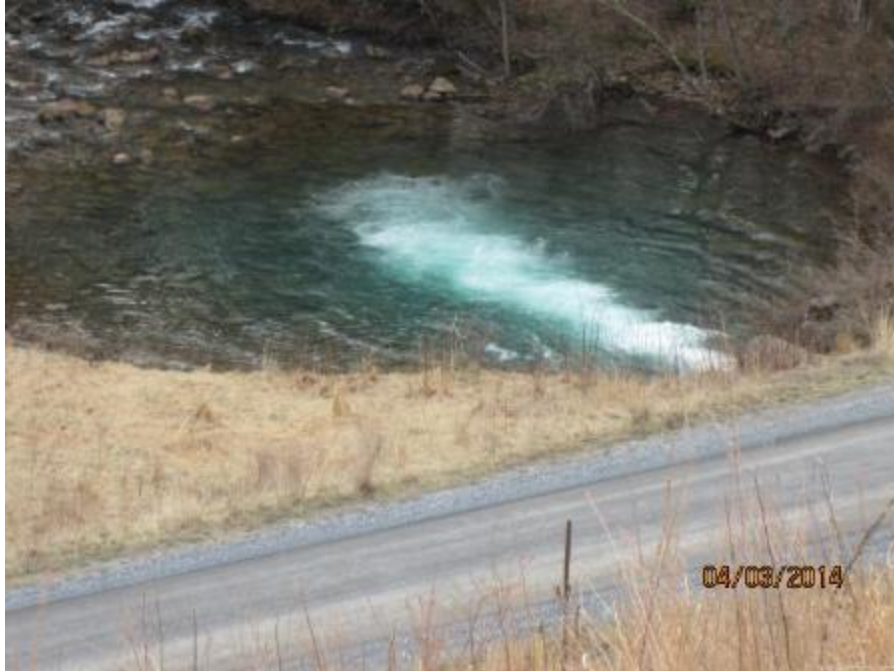
Figure 6. Principal spillway outlet flowing into the plunge pool.

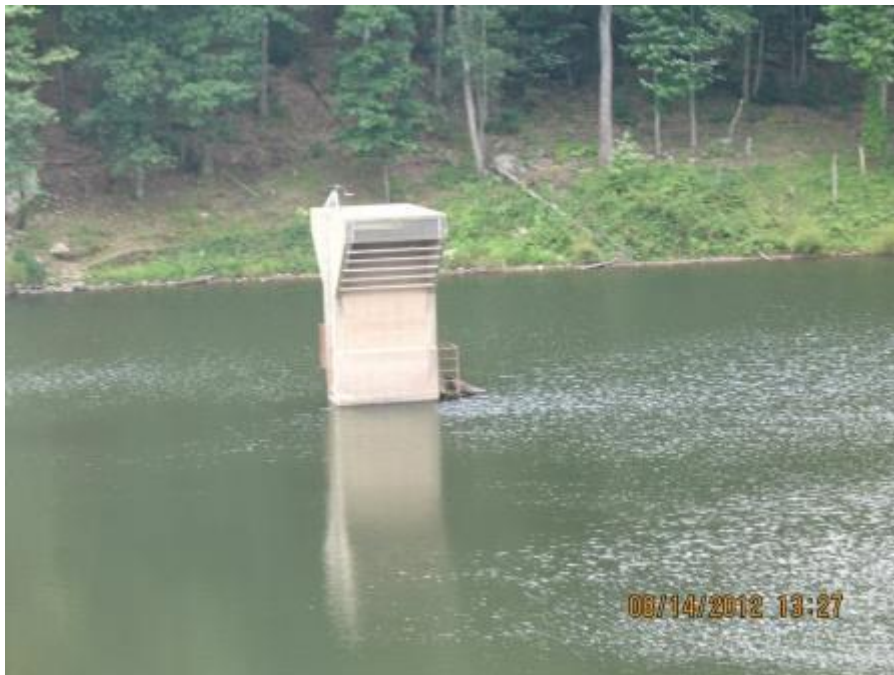
Figure 7. Principal spillway riser at Hearthstone Lake.

Riser: The principal spillway riser could be completely removed and replaced for a cost of about \$1,242,000. It would still be a two-stage structure with a cold-water release. The only major change would be the footer size and configuration. However, preliminary investigations have determined that it would be feasible to keep the existing riser tower and just retrofit the footer of the structure. The cost of retrofitting the footer would be about \$282,000. Retrofitting would include enlarging the footer, replacing the gate and all appurtenances, and surface treating the concrete, as necessary.

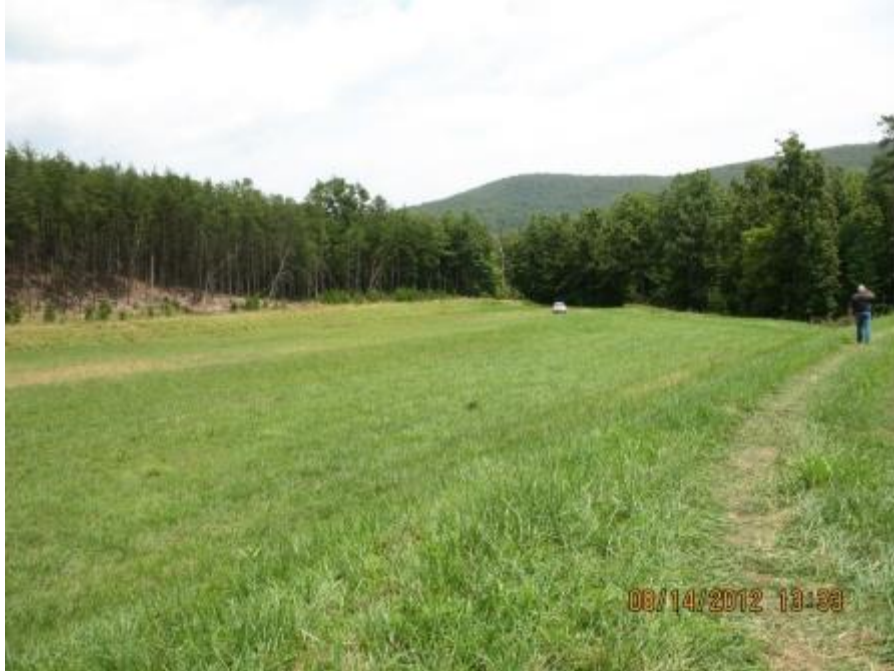
Figure 8. Auxiliary spillway, looking downstream.

***Auxiliary spillway:*** There are four parts of an auxiliary spillway. The inlet section is on the side closest to the lake. It has a gentle upward slope toward the middle of the auxiliary spillway. The water that reaches the inlet section has little or no velocity and, therefore, does not cause erosion to occur. The level center section is called the control section. The control section is usually located where the auxiliary spillway crosses the centerline of the top of the dam. The purpose of the control section is to make the water in the auxiliary spillway spread out evenly rather than concentrate into little channels. The third section is called the constructed outlet. Its purpose is to keep the water flowing out of the auxiliary spillway in a controlled manner until the water gets far enough away that it will not cause erosion on the earthen embankment itself. Once this point is reached, the water is free to go on downstream. The fourth component of an auxiliary spillway is the training dikes. Training dikes are used in conjunction with the outlet section to direct the flow of the water away from the back side of the dam embankment. Training dikes can also be used in the inlet section to direct water into the auxiliary spillway.

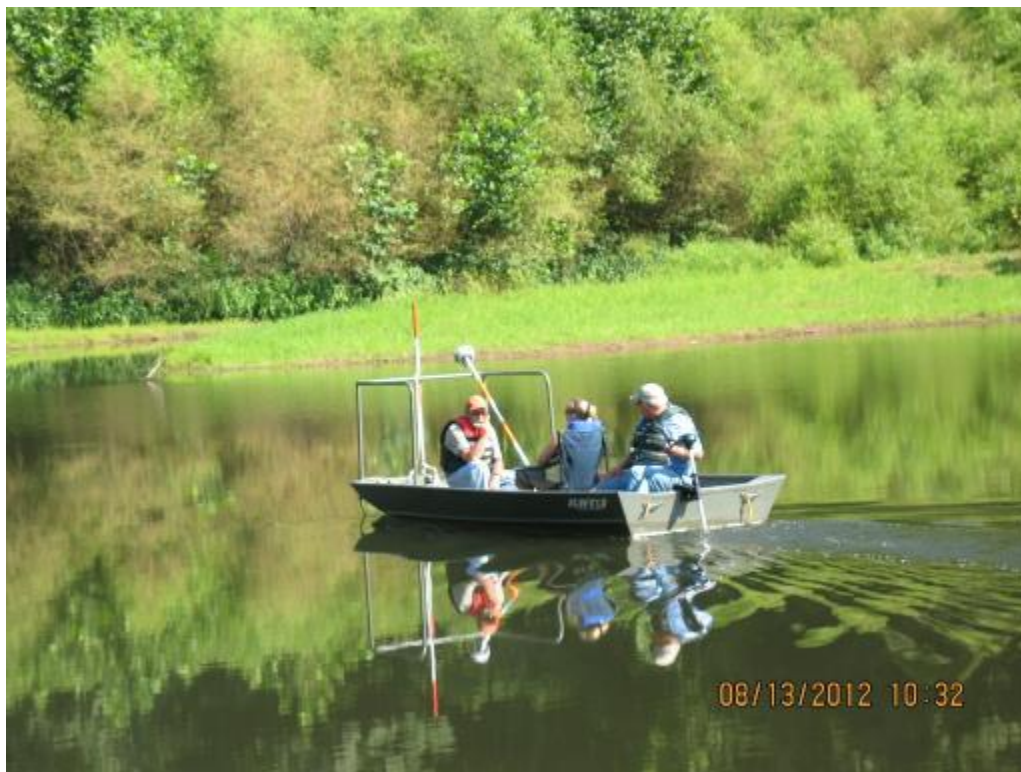
Figure 9. Sediment survey, in progress.

The structural data for the as-built condition of the dam and watershed is described in Table C. The sediment data is based upon the 2012 sediment survey.

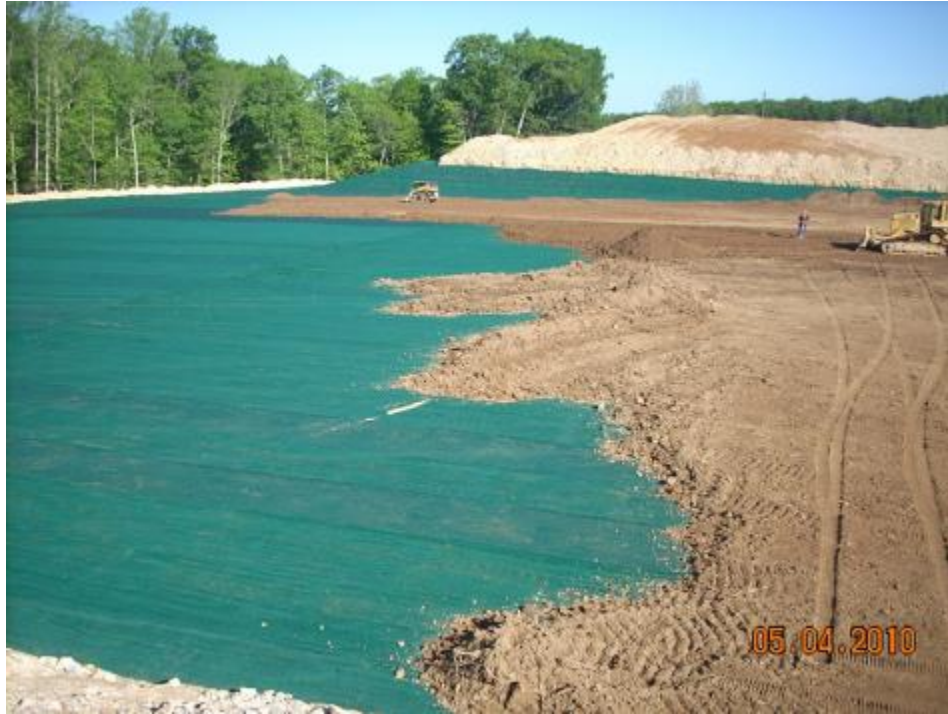
Figure 10. Installation of TRM.
